**SAS Superstructure**

Location: 04-SF-80-13.2 / 13.9

Daily Diary Report by Bid Item

Diary #: 351 Const Calendar Day: 679 Date: 19-Jul-2011 Tuesday

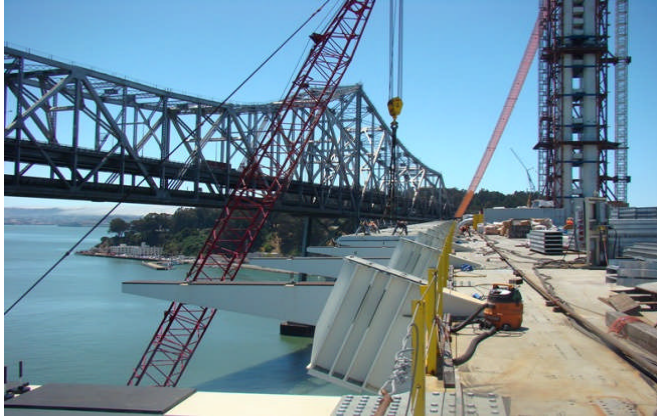
ABF ironworkers placing more bikepath panels today.

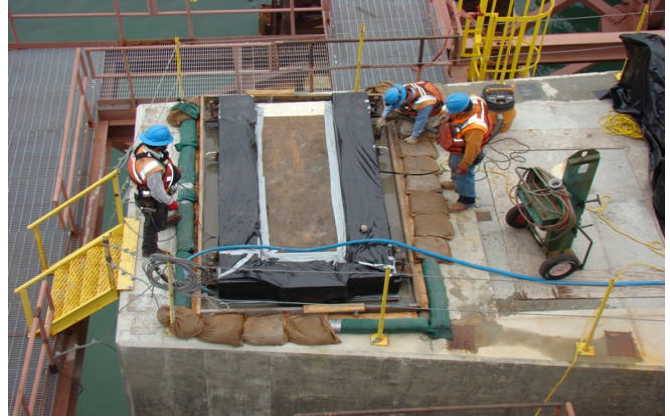
ABF laborers placing grout at the north W-Line temporary bearing while vacuuming the standing water inside the forms.

- 5.) After replacing the deficient grout hose a new one was connected and additional efflux tests were done. The first two tests failed since there were "clumps" in the mix that clogged the funnel. The third test had an efflux of 23 seconds and ABF began to pump and place the grout into the north W-Line forms. The grout temperature for the passing test was 73F and the S.G. = 2.14

- 6.) Completed placement of grout into the north W-Line pad at 9:45am.
- 7.) Completed placement of grout into the south W-Line pad at 10:10am.
- 8.) Completed placement of grout into the south E-Line pad at 10:45am. Leaks in the forms were observed for this grout pad.

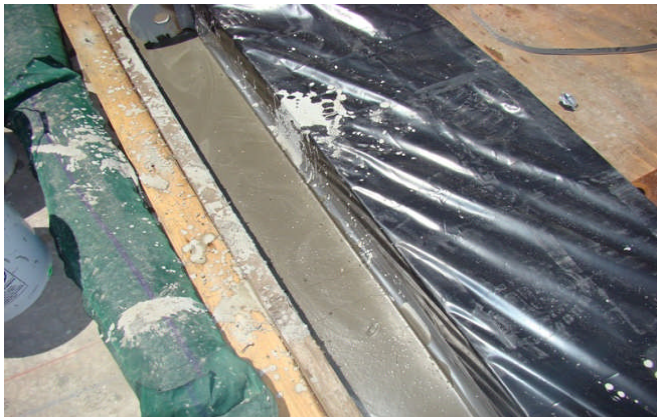
Observed thermal cracks just a few hours after the grouting operation seen on the south end of the north E-Line temporary bearing

- 11.) Lalit recommended to ABF superintendent Scott Smith to use a curing compound on the exposed surface areas of grout to prevent cracking, ABF elected to use wet rags instead.

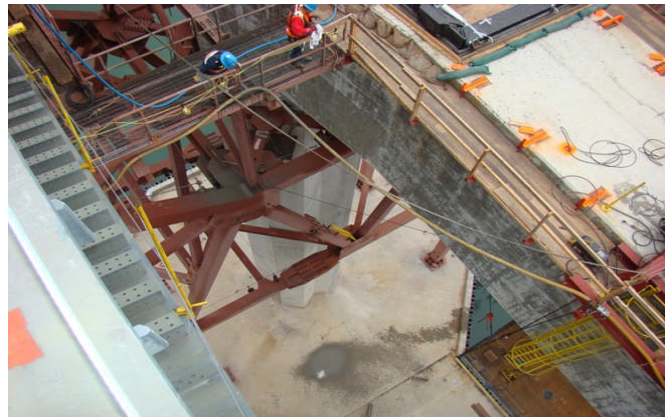
Grout was spilled onto the truss walkway, truss members and the E2 foundation. No grout was seen leaking into the bay.

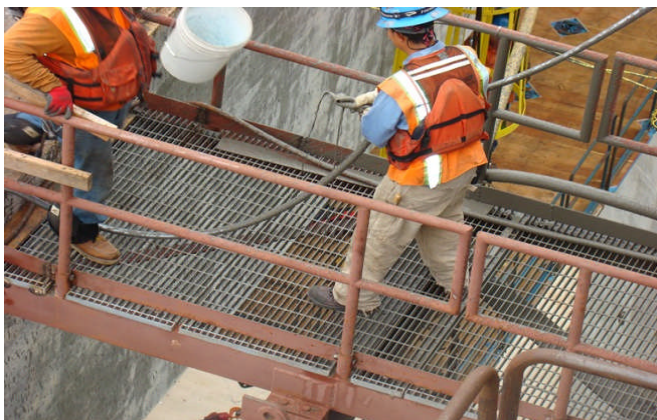
Broken grouting hose on the W-Line temporary truss south walkway.

- 4.) At 8:55am a grout hose broke on the south walkway of the W-Line truss. District 4 SWPPP engineer Robert Wong was called at this point and made aware of the issue to be onsite for the remainder of the grouting operation.

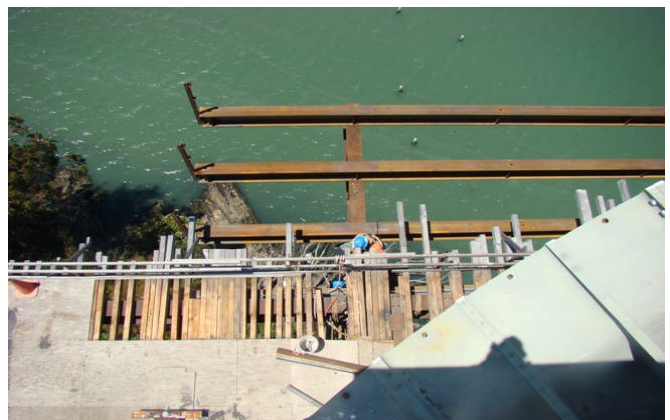
ABF ironworkers connecting the additional steel beams for the W2 working platform extension.

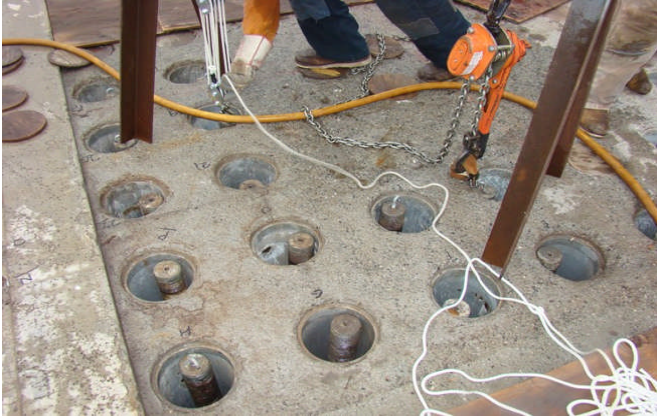
ABF ironworkers pulling the anchor rods at the E2E column Shear Key to verify which grouting inlet/outlet pipe corresponds with a particular rod.

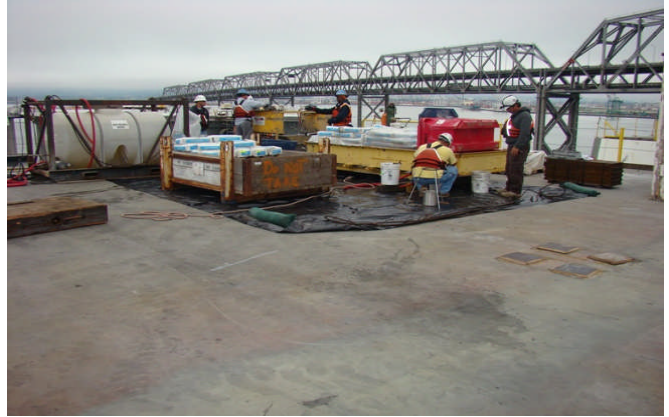
Grout mixer/pump, water tank and old Masterflow 928 grout bags used for temporary grouting operation today.

- 1.) ABF engineers Zach Lauria and Eric blue were responsible for this operation while ABF superintendent Scott Smith was supervising.
- 2.) Masterflow 928 55lb bags were used with a grout mixer/pump and the manufactures recommendation of 1.1 Gallon of Water was used with one 55lb bag of grout.

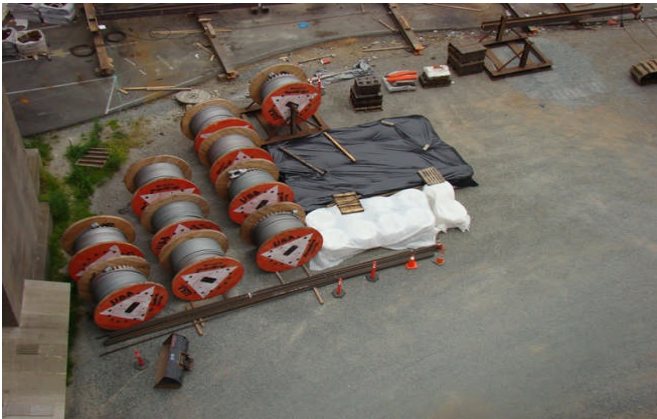
Covered Maasterflow 1205 grout superbags near the existing E1 pier on YBI.

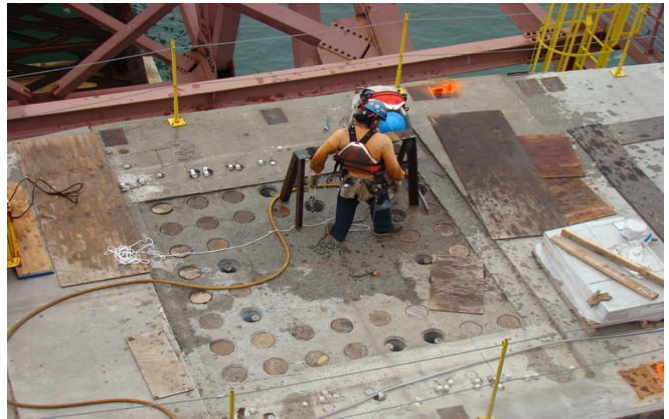
ABF ironworkers pulling the anchor rods at the E2E column Shear Key to verify which grouting inlet/outlet pipe corresponds with a particular rod.
